Manhole Inspection Summary

Manhole # S23MM_026MH

Location Address: **2487 DRUID HILL AVE**

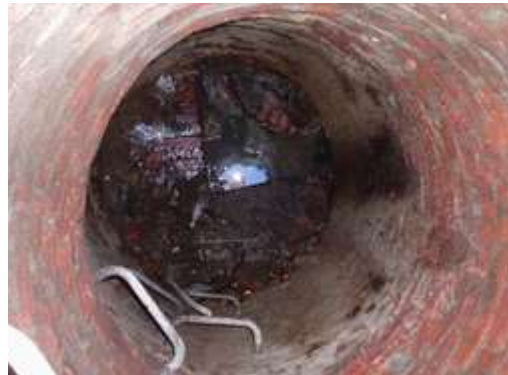
Top View

Evidence of surcharge - Bench debris.
Channel debris.

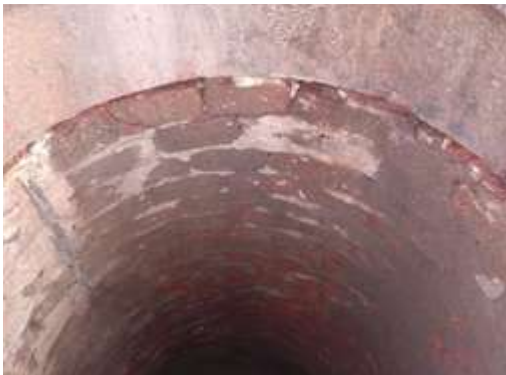
Defect

Frame leaks. Adjustment deterioration
and infiltration. Corbel and Barrel
infiltration.

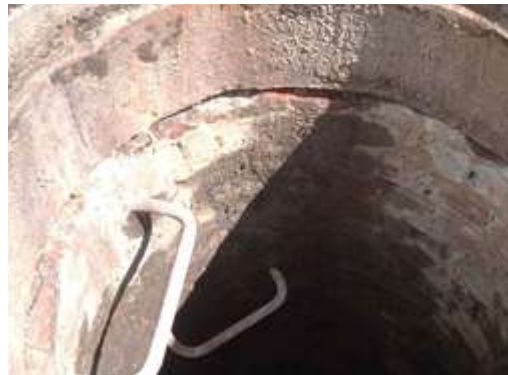
Defect

Frame leaks. Adjustment deterioration
and infiltration.

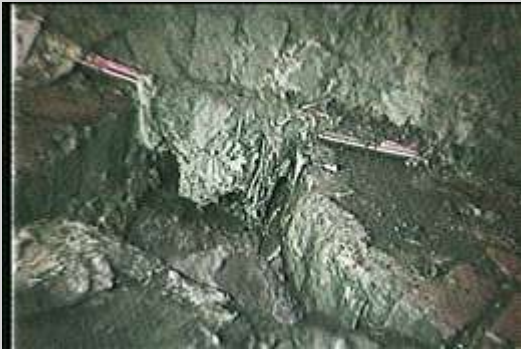
8 in. Circular Gravity Sewer Pipe Out @ 12 O'Clock

Barrel deterioration and infiltration.

Deposits: ☐ None ☒ **Mud** ☐ Sludge ☒ **Debris** ☒ **Grease**

Silt Depth: **2** (in.) Deposits Extent: **Light**

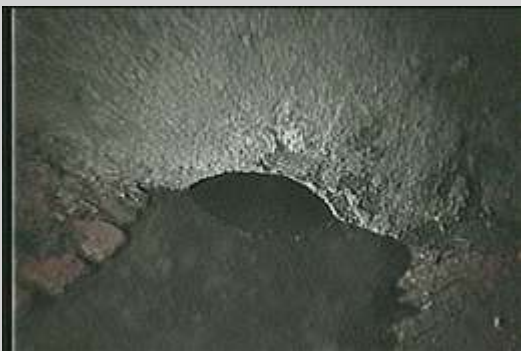
8 in. Circular Gravity Sewer Pipe In @ 3 O'Clock

Deposits: ☐ None ☒ **Mud** ☐ Sludge ☒ **Debris** ☐ Grease

Silt Depth: **3** (in.) Deposits Extent: **Medium**
